Quick Reference Handbook (QRH)

**Cessna**
C172SP G1000

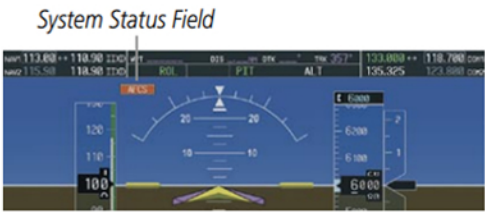
Figure 10-4 AFCS System Status Annunciation

The following alert annunciations appear in the AFCS System Status Annunciation on the PFD.

The following alert annunciations appear in the AFCS System Status field on the PFD.

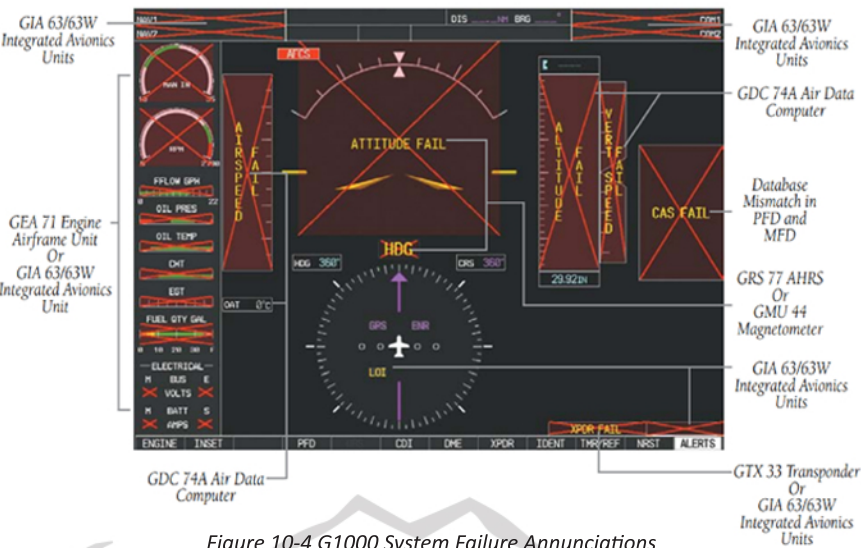
Figure 10-4 G1000 System Failure Annunciations

A red 'X' may be the result of an LRU or an LRU function failure. The Figure 10-4 illustrates all possible flags and the responsible LRU's.
